Proper **EATON** **Fuller** Output Shaft Yoke Torque Specifications

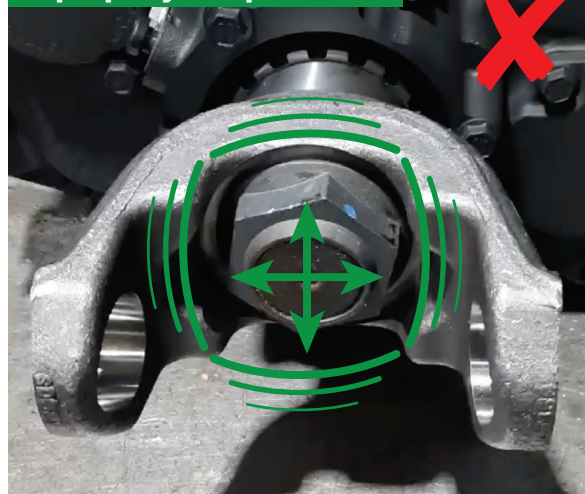
The transmission output shaft and yoke are moving side to side or up and down when installed and torqued.

The output shaft yoke to transmission has NOT been properly torqued to OE specification during the installation process of installing a transmission. Quite often the installer stops tightening up the output shaft yoke nut when their impact air wrench stops. Please note, this does not mean the nut is properly torqued.

Below is a link to a video showing the differences between a properly and improperly torqued output shaft yoke nut. When the output yoke nut is not properly torqued, the output shaft will have side to side and up down play. Additionally, there will be no output shaft threads visible.

Improperly Torqued Yoke

Note: The required torque specifications for most Eaton Fuller transmission yoke output nuts is 450- 500 ft. lbs. Unfortunately, most impact wrenches will stop functioning below 400 ft. lbs. of torque.

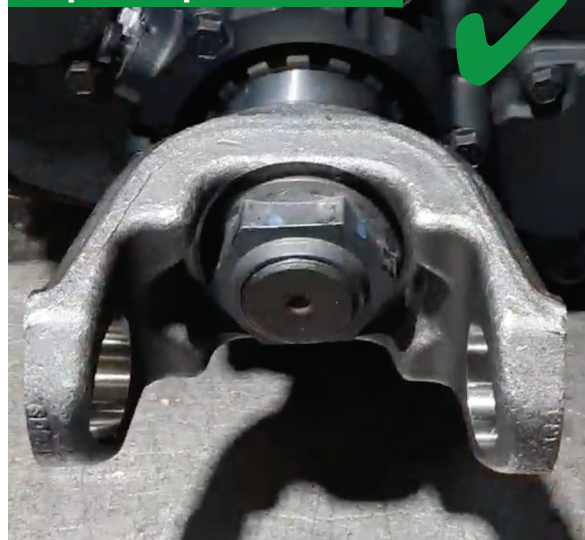
When the output shaft yoke nut is properly torqued to Eaton-Fuller OE specifications, there are visible threads at the shaft and there is no side to side or up down movement of the output shaft.

Proper Torqued Yoke
