Transmission Output Shaft Nut Loosening

Issue Description: The heavy-duty transmission output shaft nuts have been loosening.

Source: Eaton/Roadranger Service Bulletin TMIB-0193
The material contained in this bulletin is product improvement information. Eaton and Dana Corporation are not committed to, or liable for, canvassing existing products.
FSUD: 2010-FSUD-1375

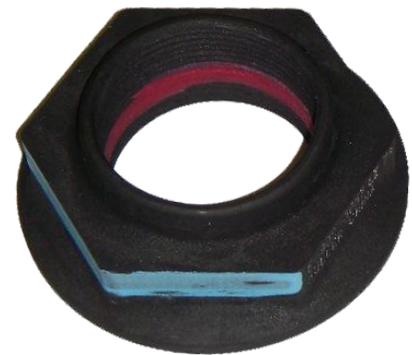
NEW OUTPUT SHAFT NUT (4306520)

The new output shaft nut (4306520) will prevent loosening and maintain the installation torque. The new nut has a crimped crown that creates interference between the output shaft threads and the nut. In addition, there is a locking compound applied to the threads of the nut.

If output nut 4302321 loosens, replace it with 4306520 and torque nut to 650-700 lb-ft.

Note: The new nut with the crimped crown requires a higher torque rating than the old nut. The higher torque is needed to seat the nut completely.
